Manhole Inspection Summary

Manhole # S21M__022MH

Location Address: **1836 eagle st**

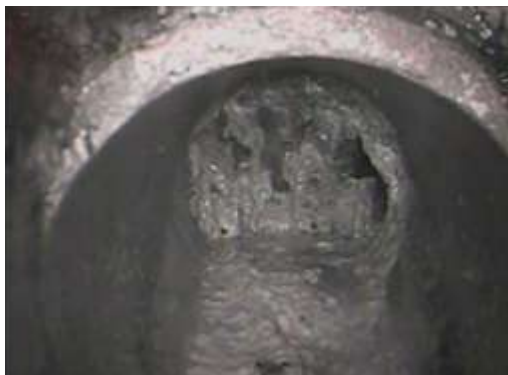
Misc

9 oclock pipe is full of grease

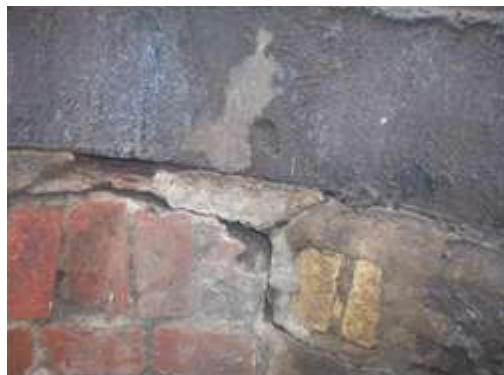
Defect 7

Condition: ☐ Sound ☒ **Cracked** ☐ Root Intrusion ☐ Loose Brick ☒ **Deteriorated**

deteriorated chimney

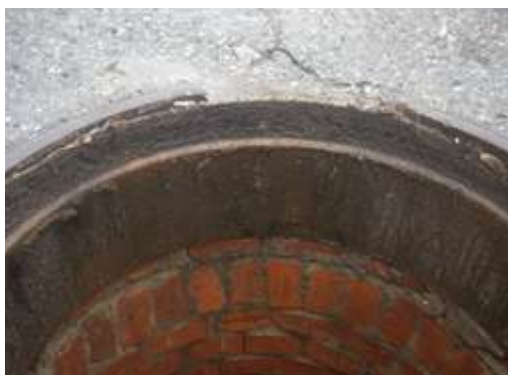
Defect 6

Condition: ☐ Sound ☒ **Cracked** ☐ Leaks

cracked/broken frame

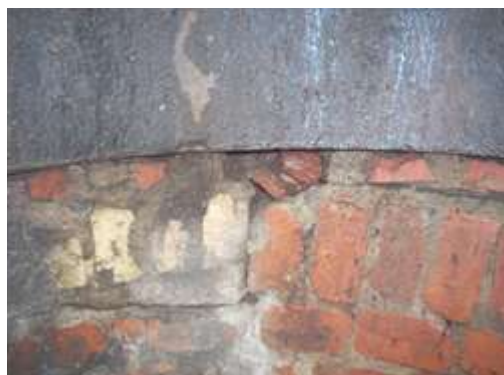
Defect 5

cracked chimney

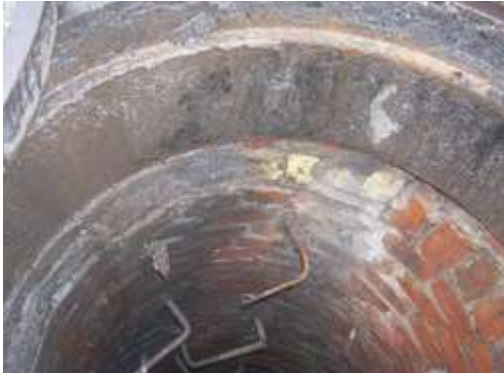
Defect 4

Count: **7** Missing: **1** ☒ **Corroded**

corroded and missing step

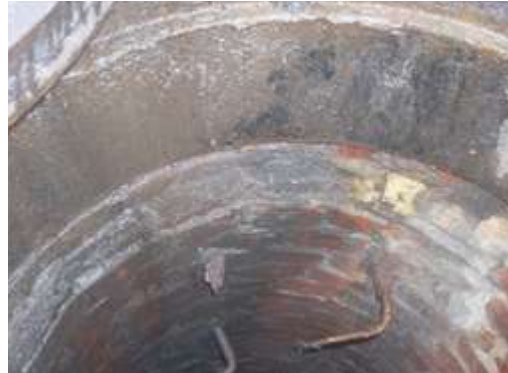
Defect 3

Infiltration: ☐ None ☒ **Joint** ☐ Cracks ☐ Mortar ☐ Roots ☐ Wall

infiltration of the joint

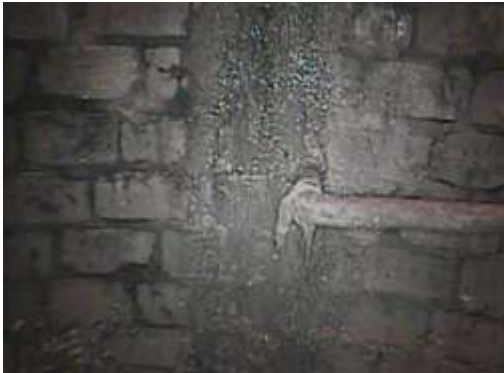
Defect 2

☒ **Evidence Of Surcharge** Depth: **3** (ft.) ☐ Active Surcharge Present

surcharge evidence on the step

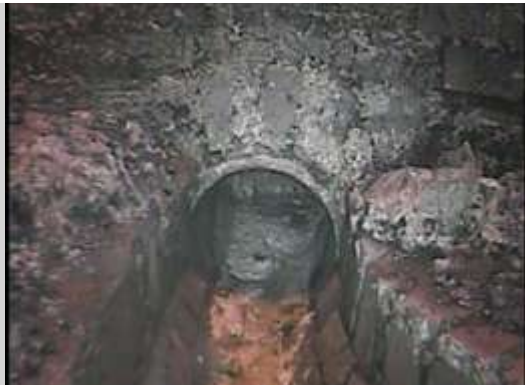
9 O'Clock Inflow

Deposits: ☐ None ☐ Mud ☐ Sludge ☐ Debris ☒ Grease

Silt Depth: **8** (in.) Deposits Extent: **Heavy**
